DYNAMIC SCIENCE, INC.
In-Depth Accident Investigation

Contract DTNH22-94-A-07049
Case DSI-96-SB-02

TECHNICAL SUMMARY

This case was selected due to a nylon coat drawstring becoming entrapped in a school bus hand rail and the wearer being dragged and run over by the school bus.

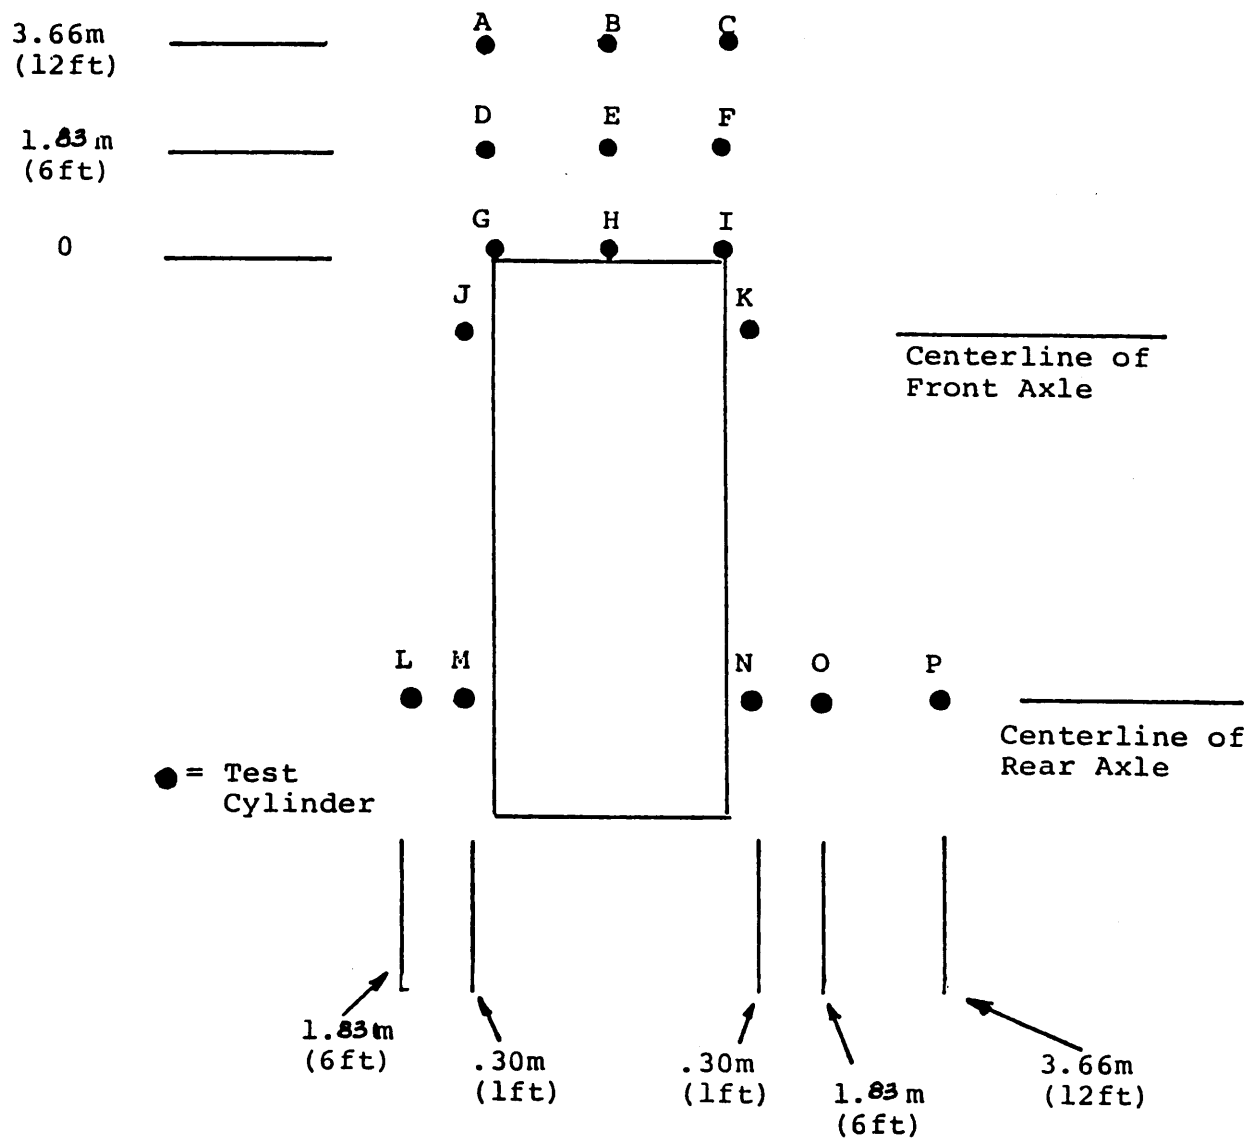
Figure 1

This school bus field-of-view test was conducted by Dynamic Science, Inc. six days post event using orange colored test cylinders measuring 30.5 cm (12 in) in height and 30.5 cm (12 in) in diameter. The test cylinders were positioned as depicted in Figure 1.

LOCATION OF TEST CYLINDERS FOR SCHOOL BUS FIELD-OF-VIEW TEST

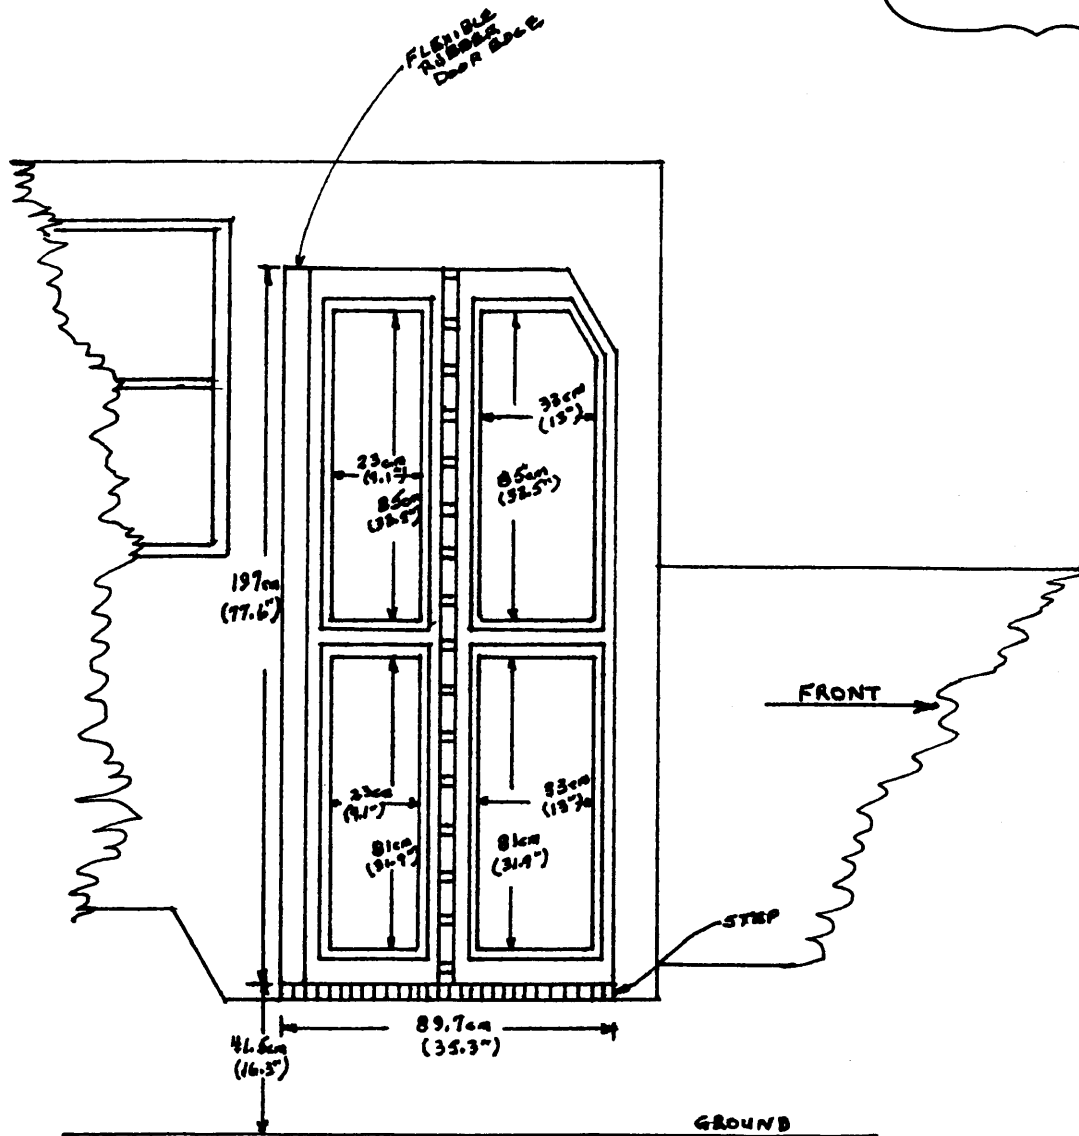
Figure 2

1. Entrance Door/Stepwell: The entry door of the _____ 66 passenger conventional school bus is a two panel, inward opening bi-fold door that measures 89.7 cm (35.3 in) in width. The three step stepwell width measures 55 cm (21.7 in) at bus floor, 65.5 cm (25.8 in) at the front of step 2 and 89.7 cm (35.3 in) at the front of the bottom step. As the bi-fold door opens inward into the stepwell, the effective usable space on the bottom step and step 2 is reduced to 60 cm (23.6 in). Because of the narrowness, clothes and other loose items are easily caught, entangled or wedged into the projecting handrail especially when passengers are wearing bulky, cold weather clothing (see Figures 2 and 3).

BUS DOOR, CLOSED - EXTERIOR VIEW

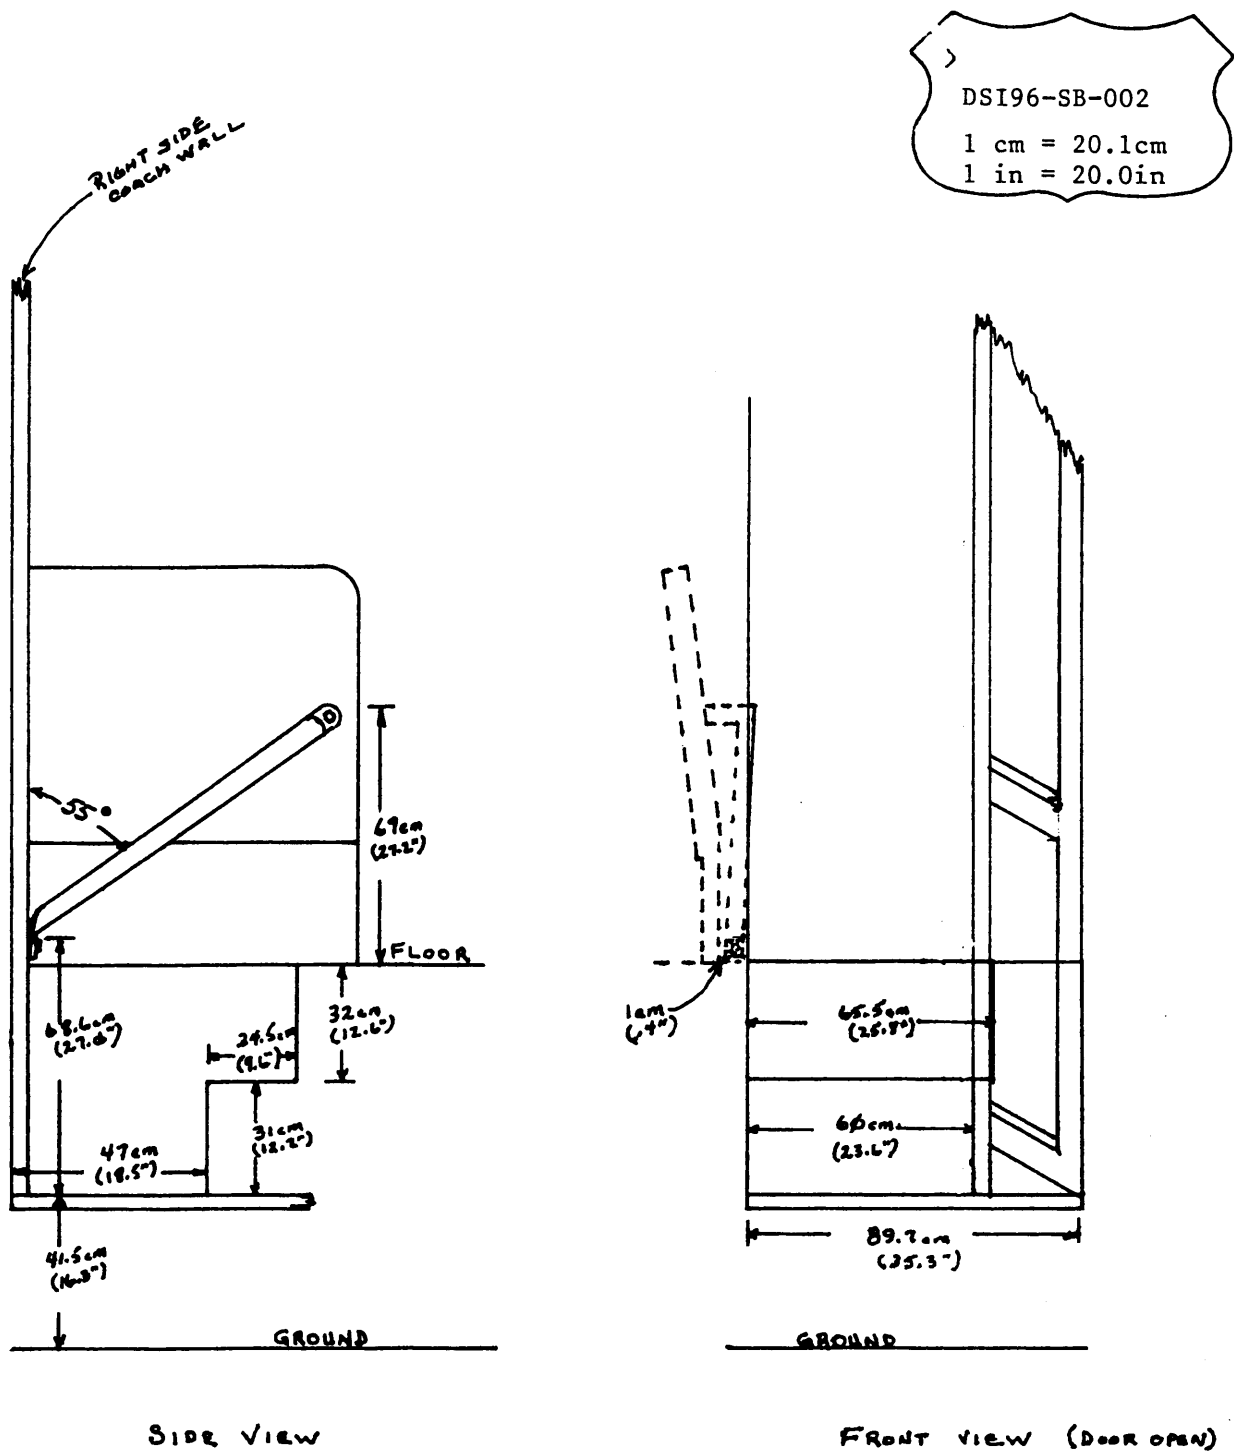
Figure 3

The 1992 66 passenger conventional school bus has a two step entry/exit stepwell with a two panel, inward opening bi-fold door. With the doors closed the bottom step measures 89.7 cm (35.3 in) in width, but with the doors open, the effective usable width is 60 cm (23.6 in). The stepwell is also equipped with a 4 cm (1.6 in) diameter tubular stainless steel grab rail mounted on the right side of the well as one exits the bus. The lower end of the grab rail is attached to the entrance door body pillar of the bus at a 55° angle and 1 cm. (0.4 in.) from the modesty panel (see figure 3).

STEP WELL
